AEROSPACE REPORT NO.
TR-92(2935)-11

Surface Contamination on LDEF Exposed Materials

15 June 1992

C. S. HEMMINGER
Mechanics and Materials Technology Center
Technology Operations

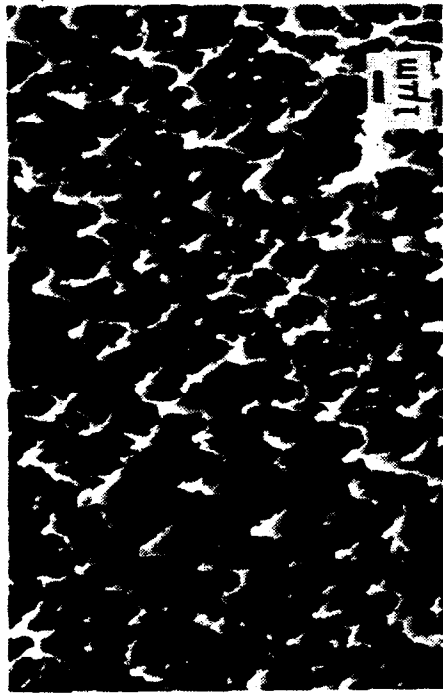
LDEF TRAY C11 EXPOSED TEFLON

The SEM and XPS results² for the exposed Ag/FEP surfaces are summarized in Table 7. The leading edge samples, from row 7 to 11, all had roughened surfaces typical of high velocity atomic oxygen erosion of FEP, as seen in Fig. 1 for FEP exposed on C11 compared to a featureless control surface. The highly textured surfaces gave rise to diffuse light scattering and the consequent cloudy appearance. The XPS data for the control surface showed carbon and fluorine only. The XPS analysis of the exposed surfaces showed that the surface composition of the FEP remaining after the erosion was indistinguishable in carbon and fluorine composition from the control, with trace amounts of some contaminants (Si, N, S, and Cl) and measurable oxygen present. This oxygen could be from the atomic oxygen interaction or from water adsorption from the atmosphere after retrieval. Water adsorption could be enhanced on the erosion-roughened surfaces which have much higher surface area than the control. The surface chemistry of these leading edge samples was identical to clean FEP Teflon, judged by a comparison of the F:C mole ratio and the C1s peak shape. The C1s spectrum from the D7 blanket surface is shown in Fig. 2a; curve-fitting revealed the major CF₂ peak at 292 eV and moderate CF and CF₃ peaks (approximately 10% each) at 289.5 eV and 294 eV, respectively. This matched the spectrum predicted for FEP with an approximate ethylene/propylene comonomer blend of 90%/10%. It appeared that deposited contaminants and damaged polymer were both removed during atomic oxygen erosion.

Fig. 1. SEM images and surface composition of FEP. A leading edge surface with atomic oxygen erosion is compared to a featureless control surface.

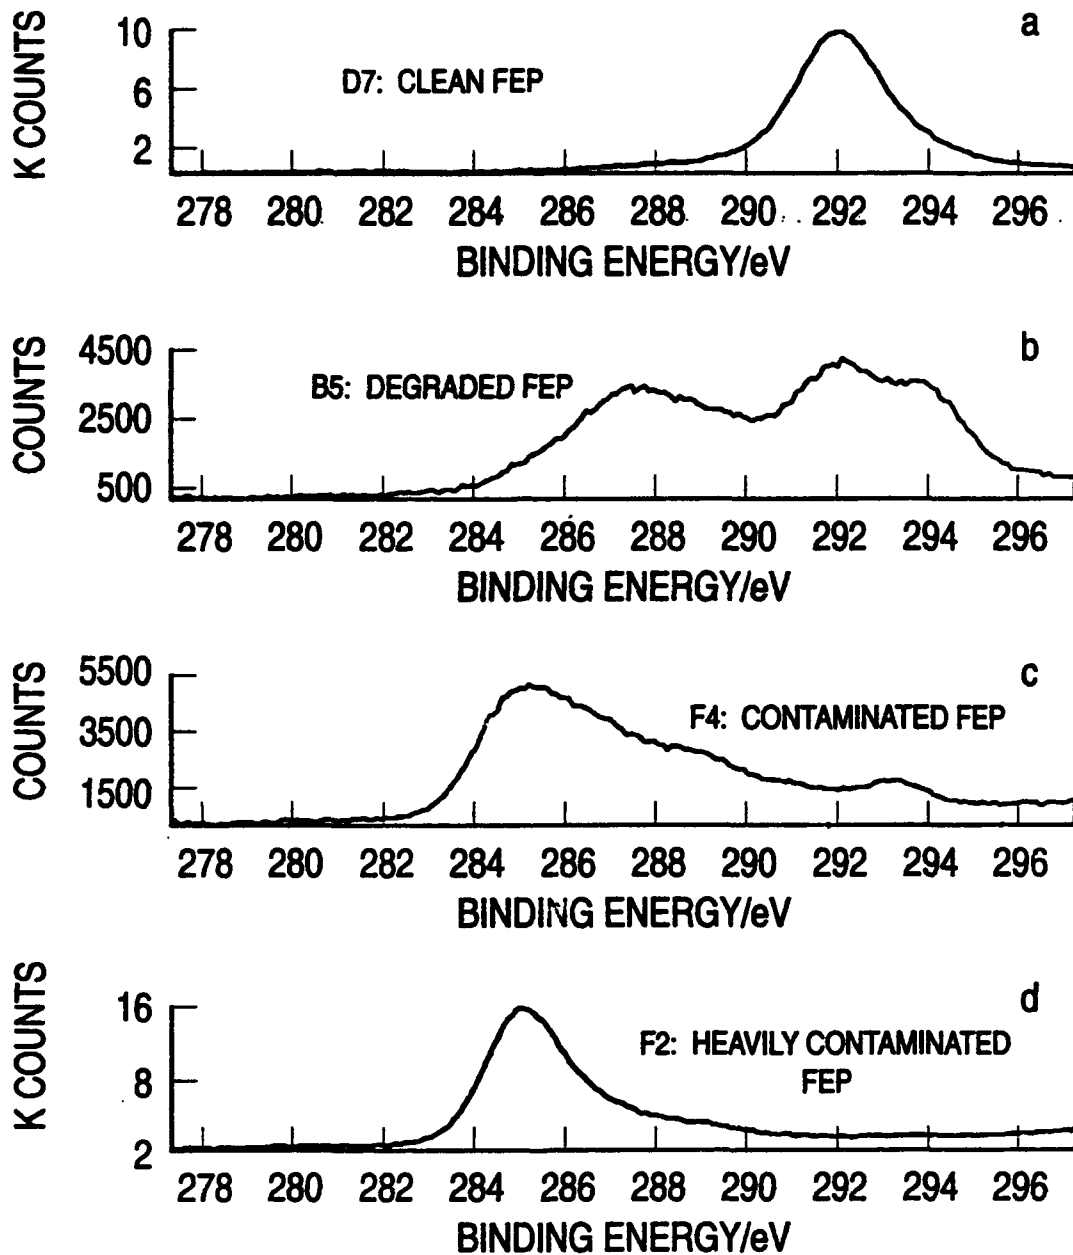
Fig. 2. XPS spectrum of the C1s peak; (a) of the D7 blanket surface representative of clean FEP; (b) of the B5 blanket surface-representative of degraded FEP.; (c) of the F4 blanket surface representative of contaminated FEP; (d) of the F2 blanket surface-representative of heavily contaminated FEP.

XPS data divided the trailing edge surfaces into two categories. The first was characterized by low contamination levels ($\text{Si} < 1\%$) and a C1s spectrum, as in Fig. 2b, that differs significantly from that of clean FEP, but does not have a major peak at 285 eV. The second category was characterized by moderate to high levels of surface contamination (Si , O , C , N , and S , and sometimes Cl) and a C1s spectrum dominated by a peak at 285 eV, as seen in Figs. 2c and d. Contaminant carbon was distinguishable from FEP and degraded FEP carbon by binding energy, and was measured at $\leq 20\%$ of the total surface composition. The C1s peak at 285 eV is predominantly due to C-C bonds, and is thought to build up on the trailing edge surfaces from decomposition products of outgassed silicones and hydrocarbons. The C1s spectrum in Fig. 2b arises from degradation of the FEP surface, for which the C1s spectrum is shown in Fig. 2a. Curve-fitting shows that the decrease in intensity of the CF_2 peak at 292 eV is accompanied by major increases in intensity at 294 eV, 289.5 eV, and 287 eV, assigned to CF_3 , CF , and $\text{C-(CF}_n)_4$, respectively. These changes are consistent with damage to the carbon backbone of the Teflon polymer resulting in molecular weight degradation, new chain terminations, branching, and crosslinking through free radical reactions. The solar ultraviolet (UV) radiation exposure of the LDEF surfaces is thought to have caused this FEP surface degradation. The FEP surfaces were also exposed to the stress of about 34,000 thermal cycles, but the maximum temperatures calculated for Ag/FEP blankets on LDEF are less than 0°C and not sufficient to break chemical bonds.³ Exposure of FEP to the XPS x-ray source for several hours induced similar shifts in the C1s spectrum; almost all of the FEP C1s spectra used for curve-fitting in this study were acquired during the first minute of sample exposure to the x-ray source to minimize surface degradation from the analysis itself. A recent study of the degradation of polytetra-fluoroethylene (PTFE) Teflon by 3 keV electrons showed very similar XPS C1s spectra changes to those seen in Fig. 2b as a function of electron irradiation and subsequent heating to drive off volatiles⁴. Degradation of the PTFE was attributed to the type of damage described above.

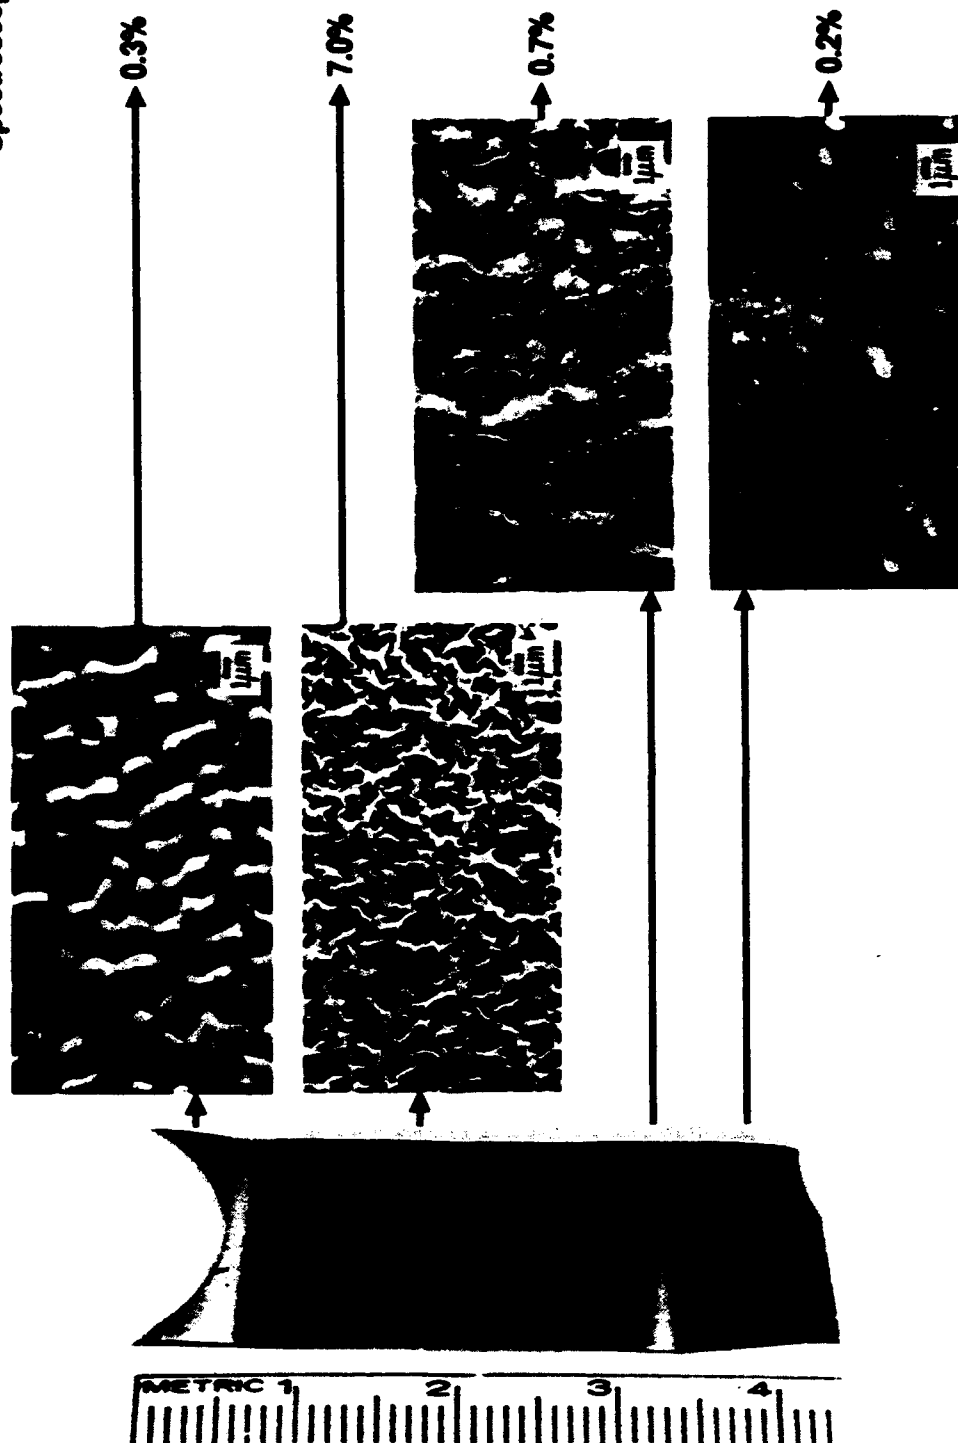
LDEF
Tray F4
Silver/Teflon

The predominant chemical state of Si identified on the trailing edge FEP surfaces was SiO_2 . Si concentrations were measured to be ≤ 20 mole %, indicating up to about 60% as the oxide. The contaminant film was definitely nonuniform over large areas, and was probably patchy on a submicron scale. Significant areas must be covered by $< 100 \text{ \AA}$ of deposited contamination, because fluorocarbon was detected on each FEP surface analyzed. The damaged FEP layer is probably thicker than the depth of analysis.

Fig. 3. SEM images of surface morphology changes observed on a section of the trailing edge F4 blanket surface. The FEP surface appeared visibly patterned, as seen in the photograph on the left. The surface contamination, represented by Si concentration, was very nonuniform.

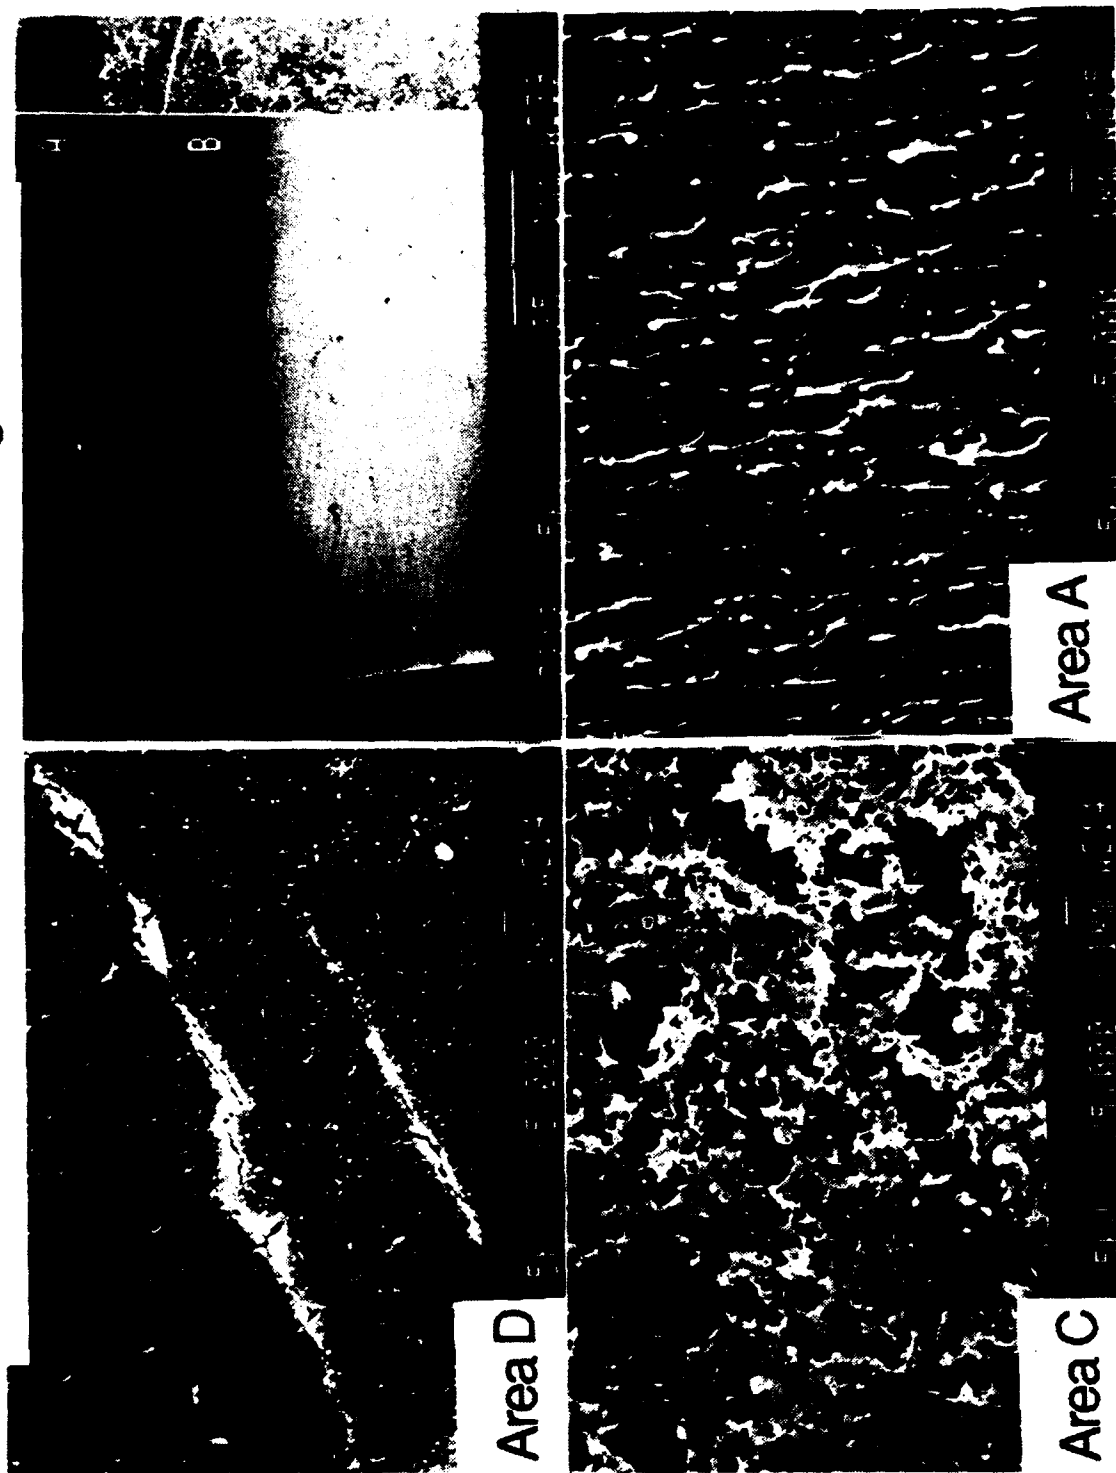
AO Erosion of A10 Thermal Blanket Edge Surface

The Ag/FEP thermal control blanket edges were contaminated, in many cases more than the exposed surfaces. Therefore, the masked edges did not provide good flight "control" samples. The transition zone from the exposed surface to the masked edge was particularly prone to contamination build-up. This was probably the result of the combination of high out-gas flux and radiation. The blankets were bent down around the edges of the tray so that the blanket edges were not rigorously shielded from radiation. SEM images from one transition zone, seen in Fig. 4, showed that during atomic oxygen erosion of the FEP surface, undercutting of the contamination and damaged polymer layer played a role in the development of a clean, highly textured surface. Area A, at the periphery of the exposed surface, had a characteristic atomic oxygen erosion pattern. Area D, closer to the blanket edge, was a surface with contamination coverage and UV degraded FEP. Area C, in the center of the transition zone, showed undercutting of the contamination and damaged polymer layer by atomic oxygen erosion. The development of submicron particles of SiO₂ was observed on some edge surfaces by SEM/EDS, as seen in Fig. 5. Such particle development was not detected on any of the other samples included in this study. Areas of orange/brown contamination were observed on some Ag/FEP edge surfaces near keyhole-shaped vent slots in the blanket edges. XPS analysis showed these stains to be high in carbon, sulfur, and nitrogen relative to other contaminated areas. The source of contamination was not identified, but it appears to have contained an amine/amide functionality.

Fig. 4. SEM images of a transition zone on the A10 blanket edge. Area A has the characteristic atomic oxygen erosion pattern. Area D is a surface with contamination coverage and UV degraded FEP. Area C shows undercutting of the contamination and damaged polymer layer.
